USAAVLABS TECHNICAL REPORT 67-35

SMALL GAS TURBINE ENGINE COMPONENT TECHNOLOGY REGENERATOR DEVELOPMENT (U)

PHASE II, FULL SCALE REGENERATOR FABRICATION AND ENGINE-REGENERATOR TESTING (U)

CONTRACT DA 44-177-AMC-181(T)
PRATT & WHITNEY AIRCRAFT DIVISION
UNITED AIRCRAFT CORPORATION
EAST HARTFORD, CONNECTICUT

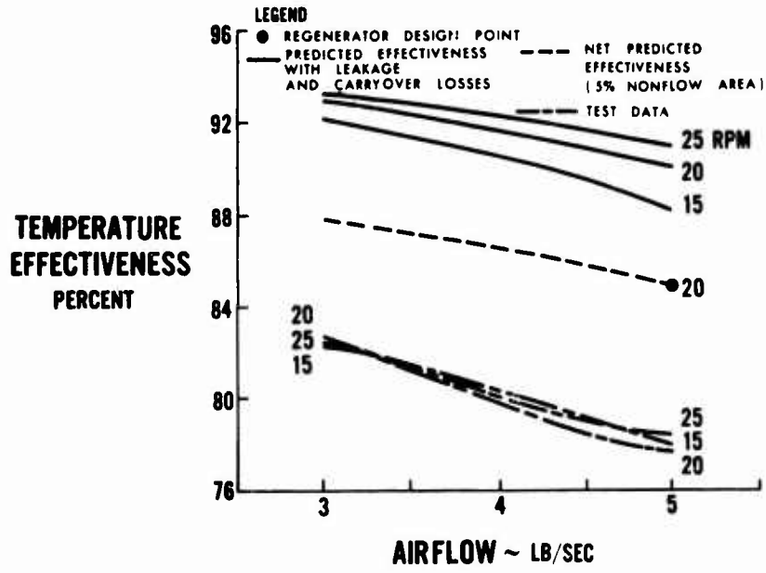
Figure 14. Regenerator No. 1 Performance in Test No. 1.

The performance goal of 85-percent temperature effectiveness was not obtained during the first series of tests. An analysis of the data indicated that there were three major suspect areas which may have caused this reduction in effectiveness. An increase in flow maldistribution at the regenerator inlets, excessive mismatch between the inlet fairing extensions with the matrix blunt ends, or flow maldistribution within the matrix could cause this problem.

Upon completion of the first performance test, which showed a temperature effectiveness of approximately 78 percent at the design point airflow (see Figure 14), both regenerator inlet ducts were flow checked. This was done to ensure that flow maldistribution at the regenerator inlet was not a cause of the low effectiveness.

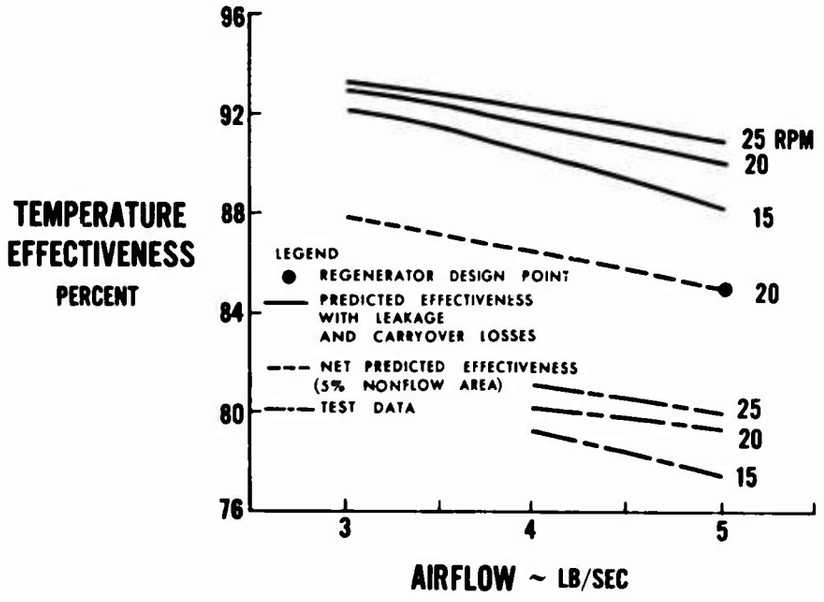
Figure 19. Regenerator No. 1 Performance in Test No. 2.

The second regenerator performance test was run with the fairing extensions of the high-pressure inlet cut back to the same plane as the flange to agree with the original design, and the bullet nosepiece in the gas side inlet duct was removed. The clearance between the fairing extensions to matrix blunt ends on the high-pressure side was increased from 1/4 inch to 2 inches. This was done since it is geometrically possible, due to mismatch of the arc-shaped fairings with the chord blunt ends of the matrix package, to mask approximately 10 percent of the screen frontal area. The results of this test run at 4 and 5 pounds per second mass flow (Figure 19) show an increase in temperature effectiveness of one percentage point and agreement in slope and spread between the predicted and test curves.

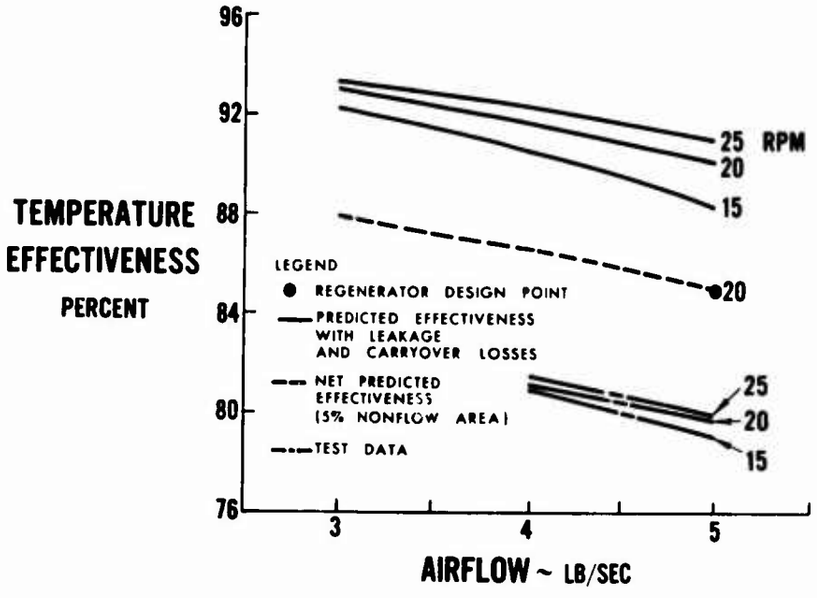
Figure 20. Regenerator No. 1 Performance in Test No. 3.

In the third performance test, the flow splitters in the high-pressure inlet instrumentation duct were removed to form a plenum at the inlet and completely eliminate the effect of fairing mismatch. The mixing splitter in the regenerator-to-burner duct was also removed to simplify evaluation of the data on the high-pressure side. Results of this test run at 4 and 5 pounds per second mass flow increased the temperature effectiveness to 80 percent, as shown in Figure 20.

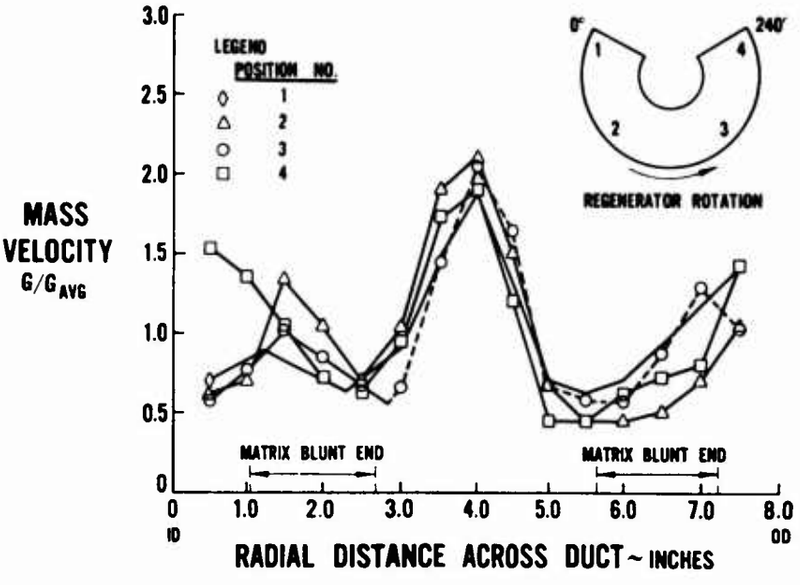
Figure 23. Flow Distribution in Gas Side of Regenerator Discharge Duct.

The results of this series of tests are shown in Figures 23 and 24. It is noted from these figures that the flow profile downstream of the package is normal. The low-flow regions are in line with the matrix blunt ends, and the high-flow region is in line with the open vee of the matrix package. The radial temperature profile, however, demonstrates that there is a poor flow distribution within the matrix package. The radial temperature profile should be flat for a uniform or equal flow per unit of matrix frontal area. The flow maldistribution and the problem of lower-than-predicted effectiveness were investigated in a single-module heat transfer rig in the supporting study described in detail in Appendix V.

It is concluded that flow distribution within the matrix package for both designs was not ideal and that this was the single cause for low effectiveness.

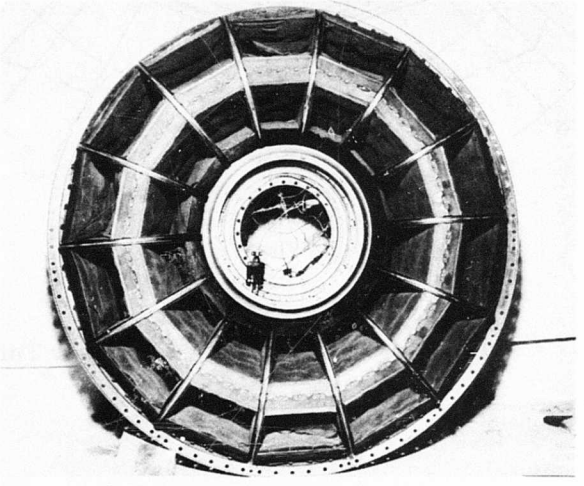
Figure 52. Deterioration of Outer Matrix Packages

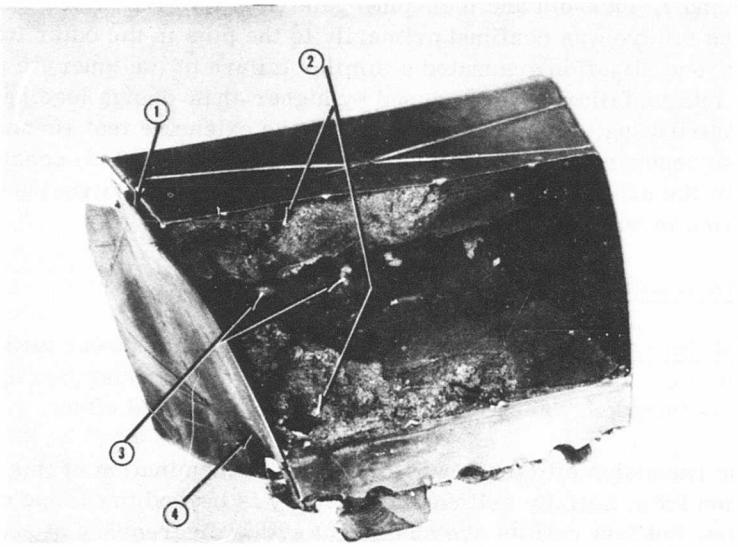
Figure 53. Front View of Burned Outer Matrix Package: (1) Broken Weld, (2) Burned Screen, (3) Fused Screening, (4) Buckled Side Plate.

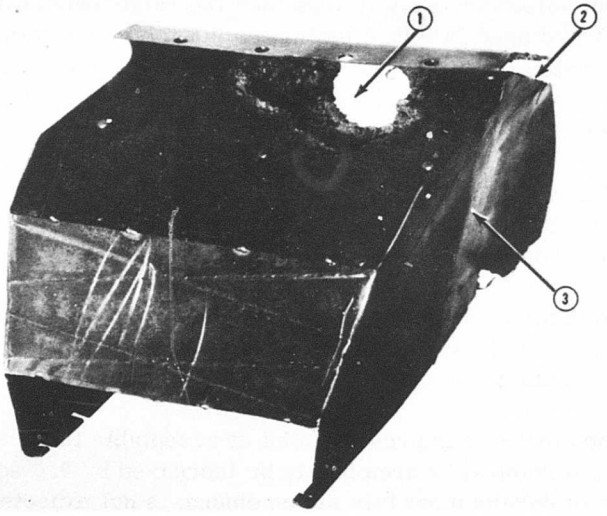
Figure 54. Rear View of Burned Outer Matrix Package: (1) Burned Screen, (2) Broken Weld, (3) Buckled Side Plate.

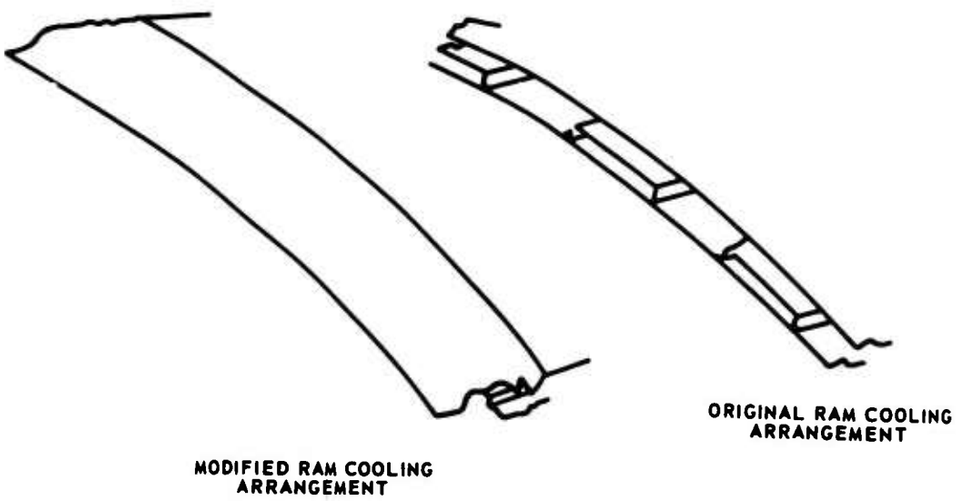
Figure 83. Original and Modified Ram Cooling Arrangements.

Performance of the new flame tube showed that the ram-air cooling strips in the existing form were difficult to control and resulted in uneven cooling air distribution and some instability. To improve this situation, a perforated skirt was incorporated over both cooling strips on the outer wall (Figure 83). The purpose of this was to meter the cooling air through the perforations and also to stiffen the flame tube wall to eliminate distortion. The beneficial effects were immediately apparent. For the remainder of the program, flame tube distortion was never a problem, and stability was satisfactory.
